# Texas Tornado

**DAMAGE ASSESSMENT REPORT**

STRUCTURAL PERFORMANCE OF  
MODERN HOMES CONSTRUCTED  
IN THE DALLAS SUBURBS OF  
GARLAND AND ROWLETT, TEXAS

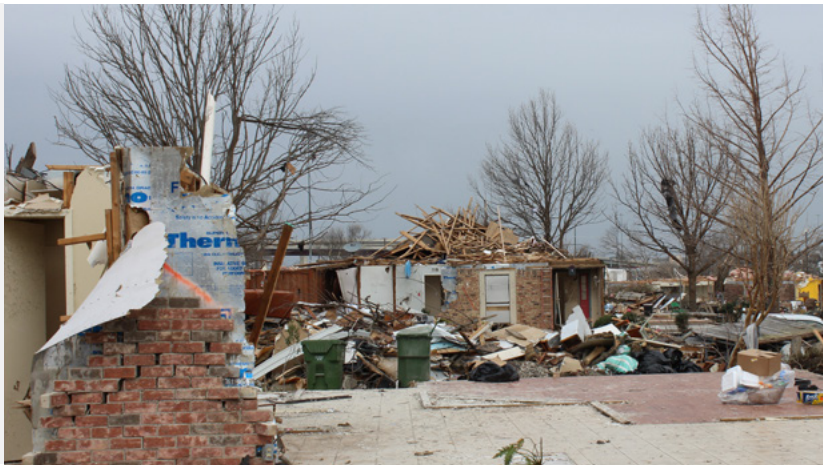
**FIGURE 5:**

A home on Barton Creek Drive, Rowlett, TX, constructed in 1992. In areas where lower wind speeds were experienced, homes fully clad with brick veneer commonly experienced cracking in the veneer adjacent to corners. This is likely due to excessive lateral displacement, or drift, for brick veneer walls sheathed with the relatively flexible laminated-fiber wall sheathing. A vertical crack that widens toward the top is visible in the brick veneer near the left-front corner of this home. Laminated-fiber wall sheathing is visible behind the brick veneer at this crack. Based on damage indicators such as nearby trees and high-resolution wind-speed contour maps by NWS, the tornado in this area is rated as EF0 rating or below. EF0 is around or below the design wind speed from ASCE 7.

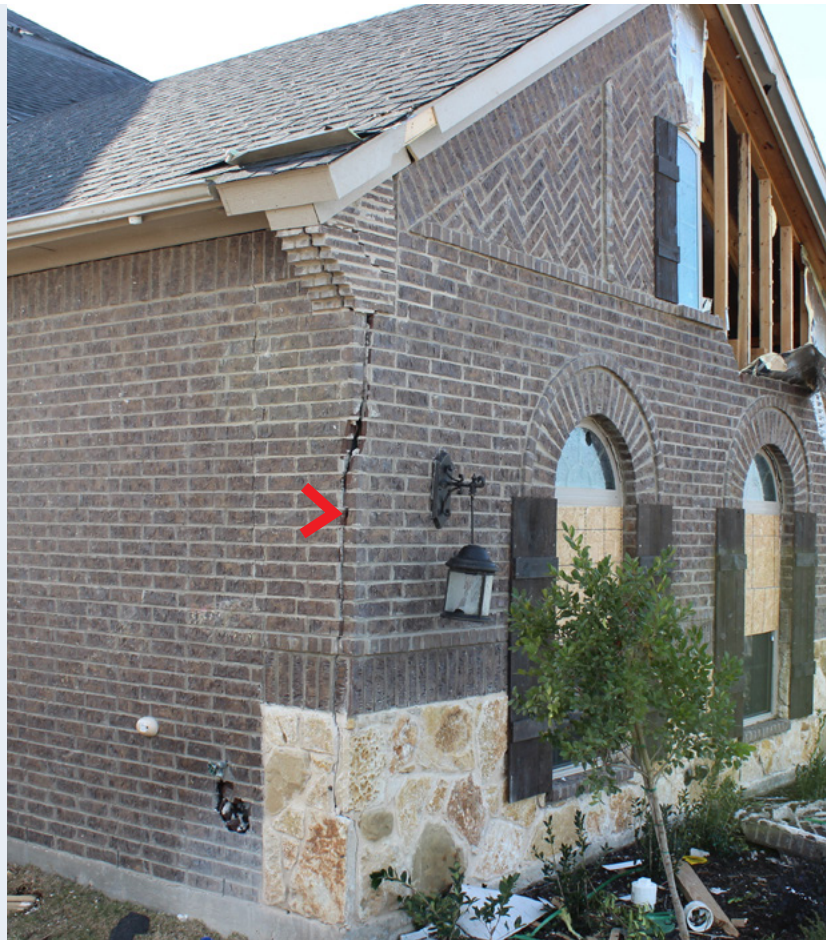
FIGURE 8:

Chianti Drive, Rowlett, TX. This is the adjacent corner of the home shown in the previous photo. Cracking in the brick at the corners of the garage door opening are present in addition to the collapsed brick. Loss of stone veneer was also observed where it stacks continuously from the foundation to an area above the roof, visible on the right of this photo.

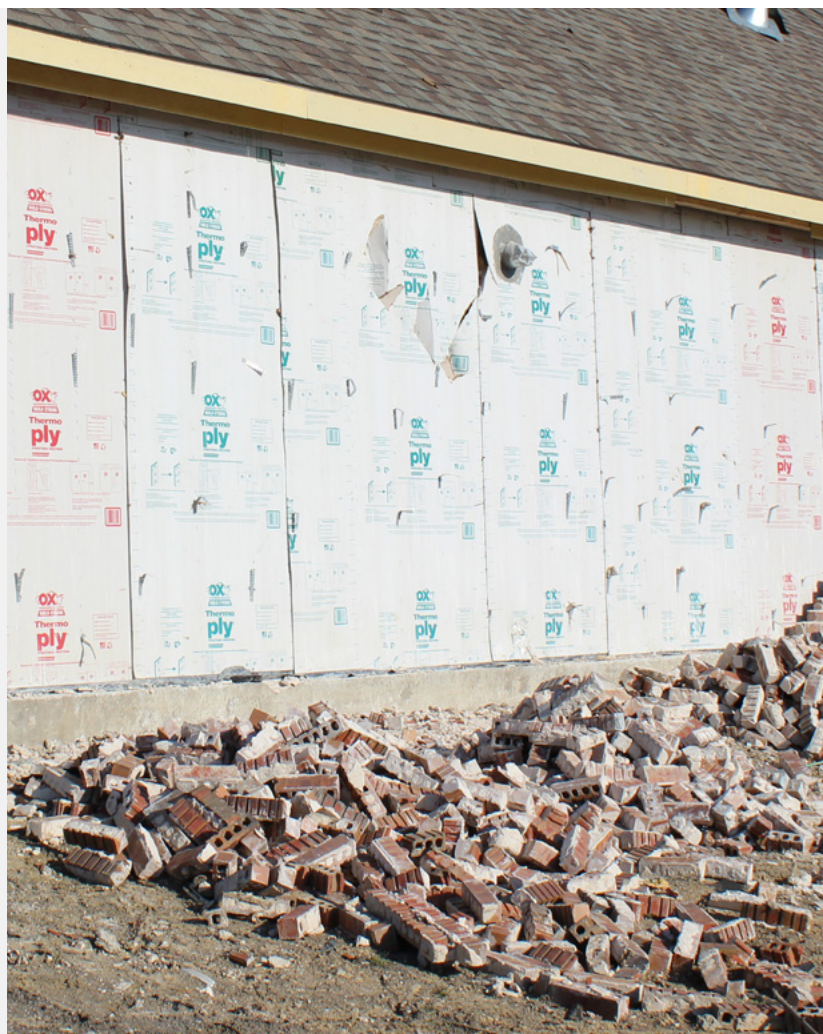
FIGURE 11:

This home located in Rowlett, TX, is typical of many homes partially destroyed by the tornado. Failures were initiated adjacent to the large openings such as this garage door. Wind in this area was consistent with a rating of EF0 to EF1 based on the degree of damage to roof coverings and nearby trees. Garages are more vulnerable to damage since they are less structurally redundant and often lack adequate lateral bracing at the walls containing the large vehicular opening. When a garage door opening is breached and wind force is exerted on the interior of the garage, internal pressure combines with those already on the exterior, often resulting in sudden and catastrophic failure.

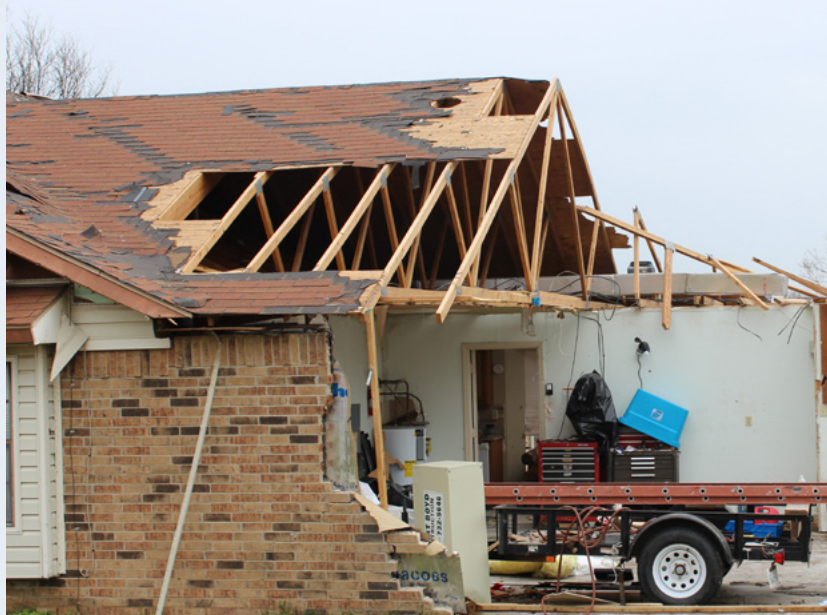
FIGURE 12:

This home has sustained damage primarily at the garage location despite relatively low wind speeds. Damage indicators on the home and nearby vegetation suggest a tornado rating of EF0 in this area. Pressurization in garages and low strength of the structural systems (note narrow width of laminated-fiber sheathing at return wall) resulted in a large number of homes with damage initiated from the garage area. Lateral flexibility of the walls subjected to wind forces resulted in brick veneer that has collapsed into, and away from, the interior homes.

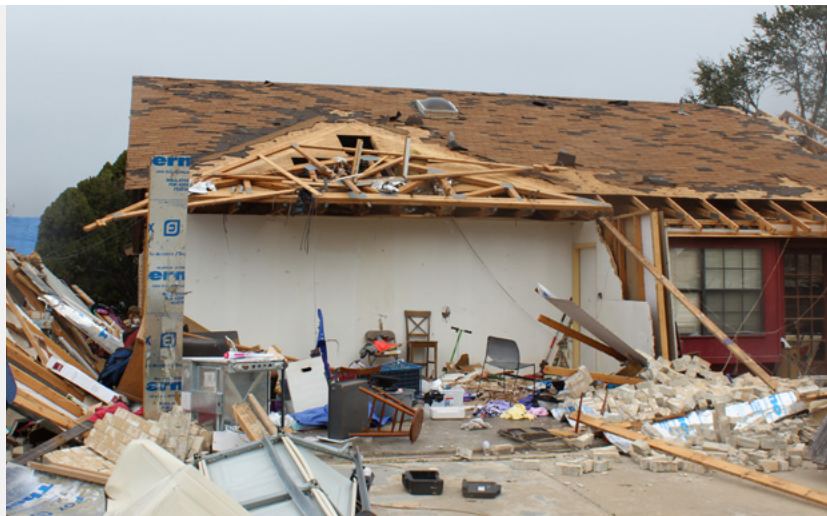
FIGURE 13:

Racking of this garage end wall occurred in an area affected by only moderate winds (note virtually no loss of roof coverings.) Inadequate resistance to lateral forces by return walls on each side of the garage door opening was a common observation in the storm-damaged areas of Garland and Rowlett. These narrow walls were typically sheathed with laminated fiber and were unable to transmit lateral forces around the openings. The narrow wall segments adjacent to the garage opening are important for structural safety and must be properly constructed in accordance with the code.

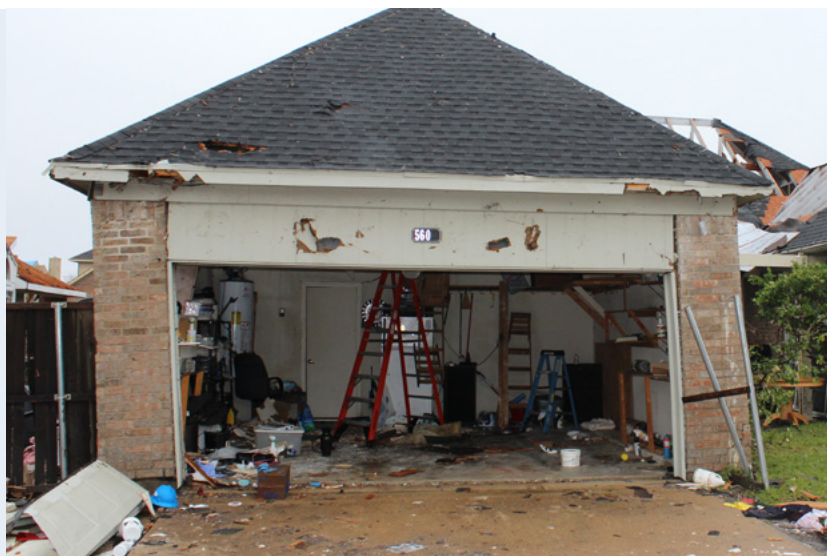
FIGURE 14:

As wind forces on homes increased, damage observations commonly included racking of wall systems around garage openings and loss of brick veneer. As with previous storm observations, garages were often the location in homes where damage was initiated. After a breach in the garage, loss of roof and walls in adjacent living spaces was often seen as a result.

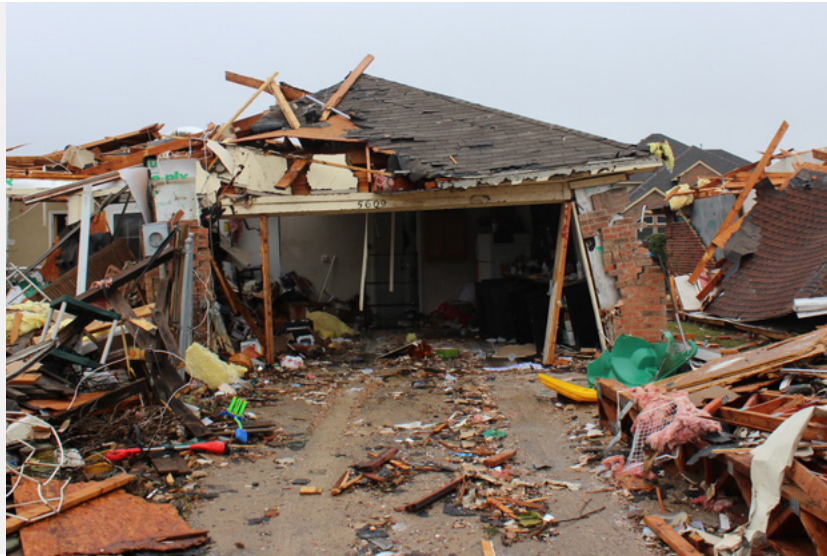
FIGURE 15:

In the outer reaches of the tornado, homes were often observed with damage at the garage only. Attached garages represent the weakest area of many homes and this was typical in the areas of Garland and Rowlett. Pressurization of the garage at this location resulted in loss of the walls and roof, despite relatively low tornado wind speed ratings of EF0 and EF1. Laminated fiber stapled to wall framing, visible on the left side of this garage, offers relatively low strength and lateral stiffness.

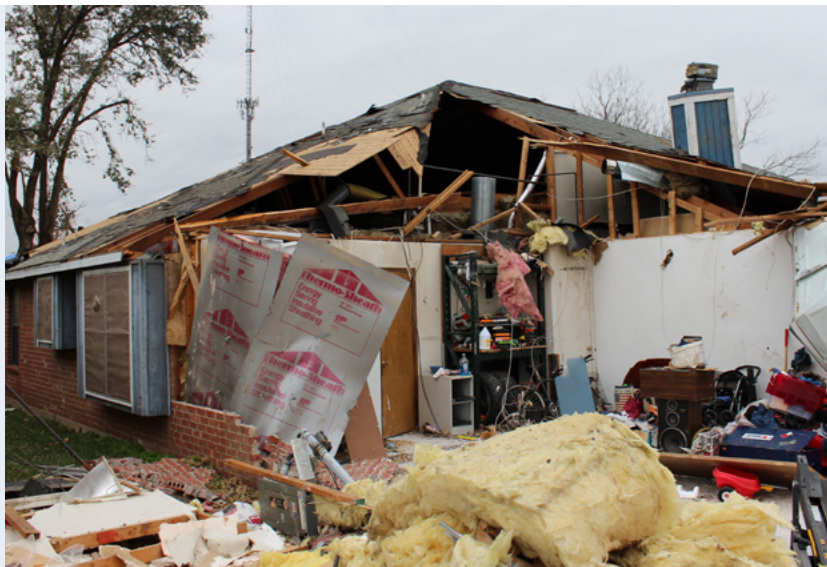
FIGURE 16:

Garages that project past the front or rear of homes are more vulnerable to lateral forces and structural failure. This garage failure represents the majority of damage sustained by this home. Based on the damage indicators of vegetation and roof coverings, the tornado rating was between EF0 and EF1 in this location.

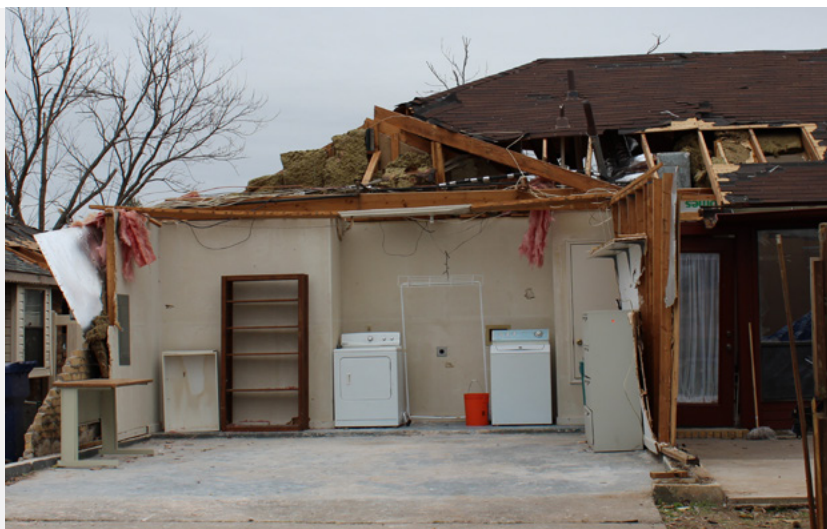
**FIGURE 17:**

This home on Windjammer Way in Rowlett, TX, is near the tornado landfall on the southeast side of the Rowlett peninsula. Damage in this area is consistent with an EF2 rating. Wall racking resulted from inadequate capacity in the narrow bracing segments. Rotation at the top of the garage return wall on the right is evident in this photo.

Portal frames around garage openings, or other force-resisting systems, are generally required by codes in locations such as this. Through careful detailing of the wall sheathing at the narrow return walls, site-built portal frames resist rotation by incorporation of the return walls with an extended garage-door header. Garages with living space above are more likely to require portal frames since the taller walls and roofs above present a larger area for wind pressure to act.

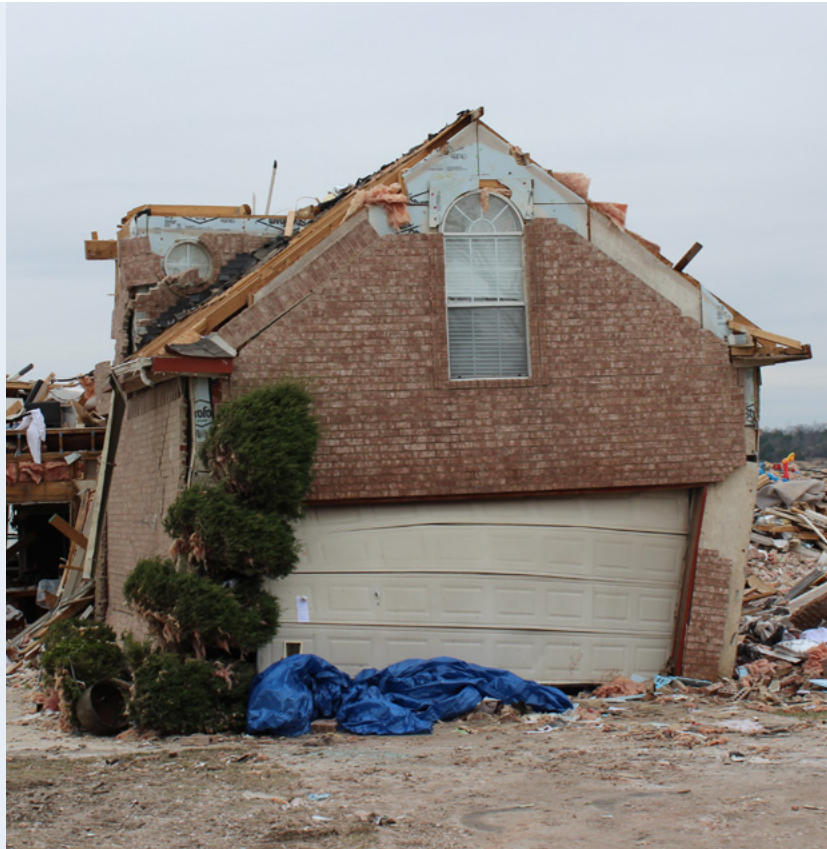
**FIGURE 18:**

Constructed in 2012, this 1-1/2 story home on Lindsey Drive in Rowlett, TX, was impacted by the tornado within the range of EF1 to EF2 rating, based on the degree of damage to vegetation and roof coverings of nearby intact homes. The large roof formerly covering the garage and upper-level living space was probably lost after the garage opening was breached and the interior was pressurized. Poor load-path continuity made damage to this home much worse than what would be expected in a well-constructed home. The survival of the second floor walls surrounding the living space can be largely attributed to the interior drywall, since foam sheathing on the exterior of these walls has no significant strength.

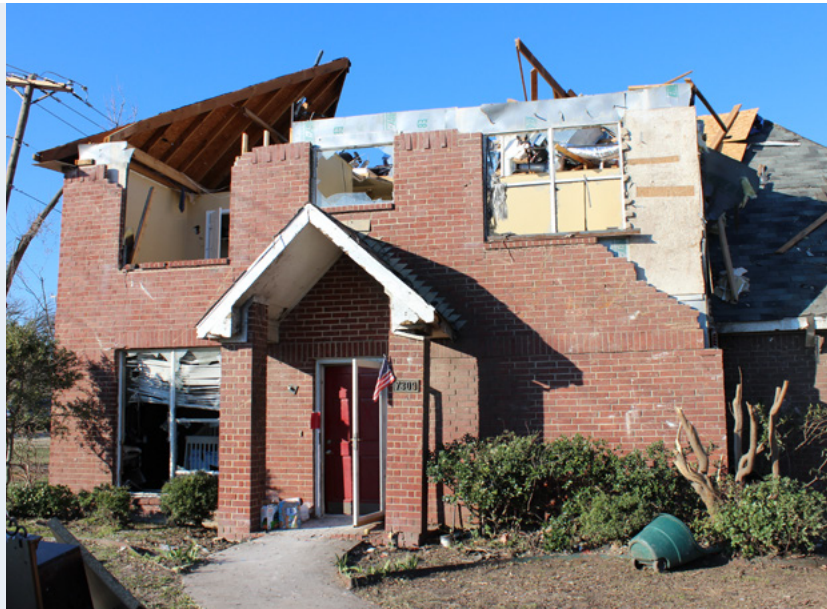
FIGURE 26:

This all-brick two-story home on Harbor Drive in Rowlett sustained significant damage after losing the roof. Many of the second-level brick-covered walls have collapsed inward. Brick veneer that collapsed adjacent to the front corner of the home was most likely toppled due to excessive lateral drift of the structure. Torn laminated-fiber wall sheathing is visible where falling brick pulled away from wall framing members. Maps by NWS rate the tornado at a maximum of EF2 along this section of the path, although damage to vegetation indicates it may have been rated lower at this particular location. A home with a better constructed and continuous load path would have likely survived with minimal damage in this location.

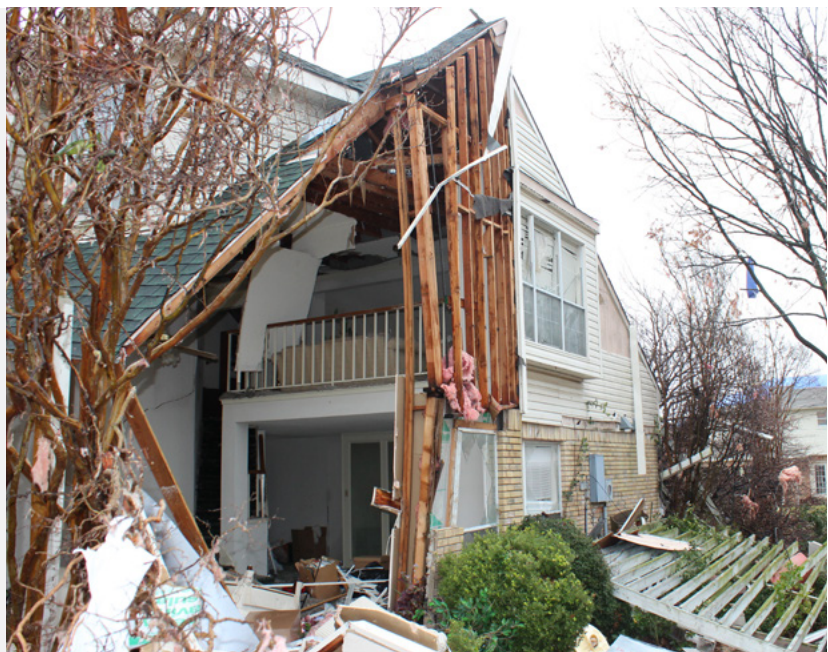
**FIGURE 29:**

This home located on Willowbrook Drive was intermittently sheathed on walls with WSP and infilled with laminated-fiber sheathing. Soft-story failure in this home resulted from inadequate capacity of wall systems to carry lateral wind forces. Collapses such as this obviously represent a serious life-safety issue. An abundance of openings on the first story walls of this home should signal the designer to pay special attention to the wall bracing specified in the building code for lateral resistance. In addition, a very limited number of brick veneer ties were observed on this building.

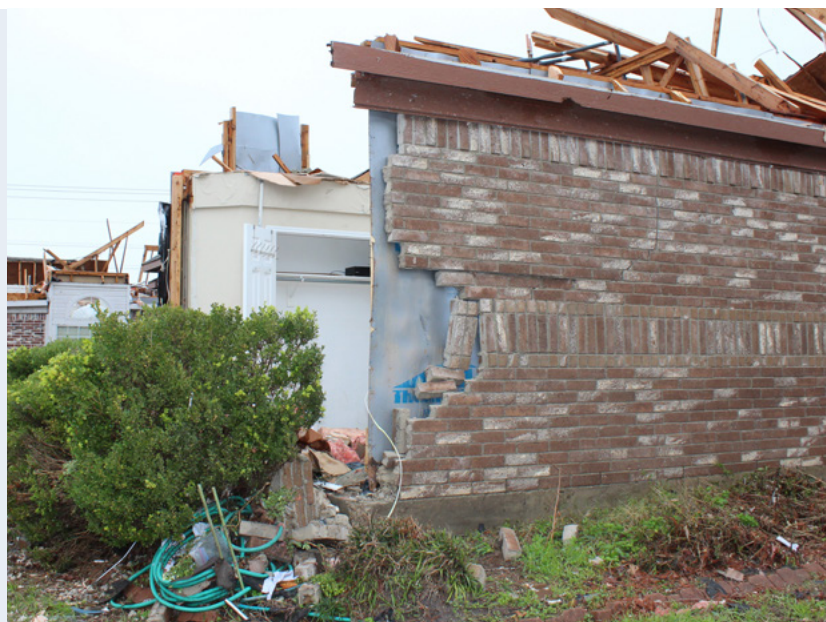
FIGURE 36:

Laminated-fiber sheathing used as wall bracing was observed to be torn in this location near the corner of this home. In addition, note that the top plate is not lapped by the wall sheathing.

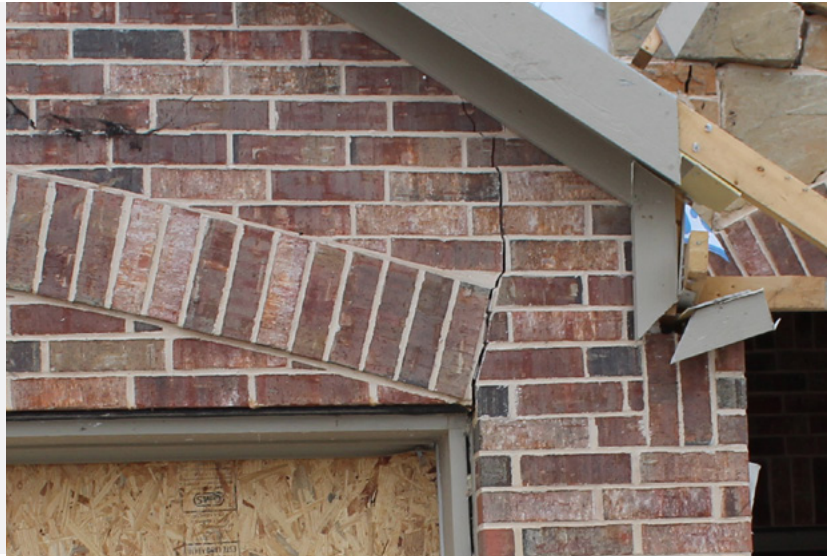
**FIGURE 40:**

Built in 2011, this home on Lindsay Drive in Rowlett has a crack in the brick at the corner that extends the full height and widens toward the top of the two-story brick cladding. The in-plane wall deflection is not commonly considered in design, but it may be important to do so when the wall is constructed with brittle brick veneer and flexible sheathings such as laminated fiber and foam plastic sheathing.

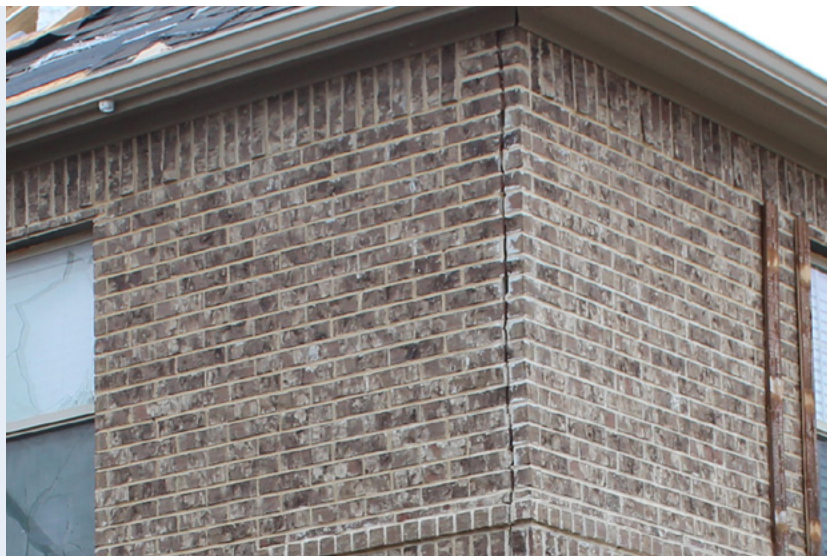
**FIGURE 41:**

This newly constructed two-story home on Lindsay Drive in Rowlett sustained vertical cracks near the corners after exposure to relatively light winds. Failures of this type have not been commonly observed in past damage assessment observations after similar high wind events, as use of laminated-fiber wall sheathing is very limited outside of Texas, and the use of laminated-fiber sheathing combined with brick veneer is even more rare.

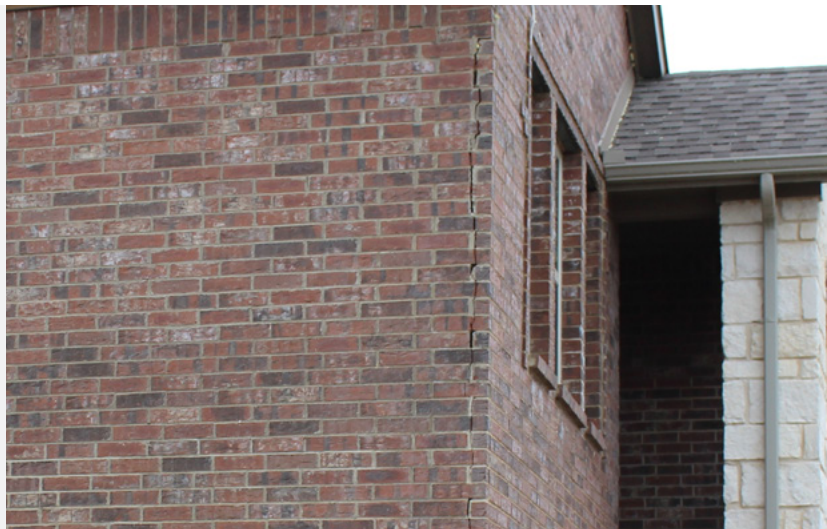
FIGURE 42:

This is another home on Lindsay Drive in Rowlett which was constructed in 2011. Flexibility of walls adjacent to garage doors resulted in cracks near corners in brick veneer. In areas of lower wind speed, cracking and loss of brick veneer were the primary areas of damage to many homes. Note the standing fence in the backyard, indicating low wind speeds.

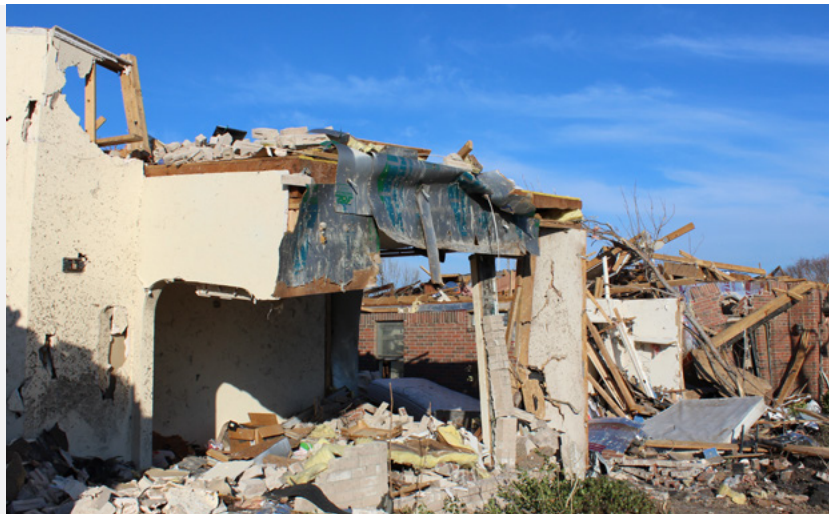
FIGURE 44:

This home on Harbor Drive in Rowlett was built in 1992. Laminated-fiber wall sheathing did not provide enough rigidity to support the brick veneer. This is especially true on two-story homes. Brick was observed to collapse both inward or outward and represents a danger to occupant safety. (Note the laminated-fiber sheathed wall from second story draped over edge of floor system.) Also note that surrounding vegetation is largely intact. Based on affected vegetation, damage indicators from nearby homes, and high resolution contour maps of the tornado by the NWS, the tornado rating is estimated to be EF1 in this area.

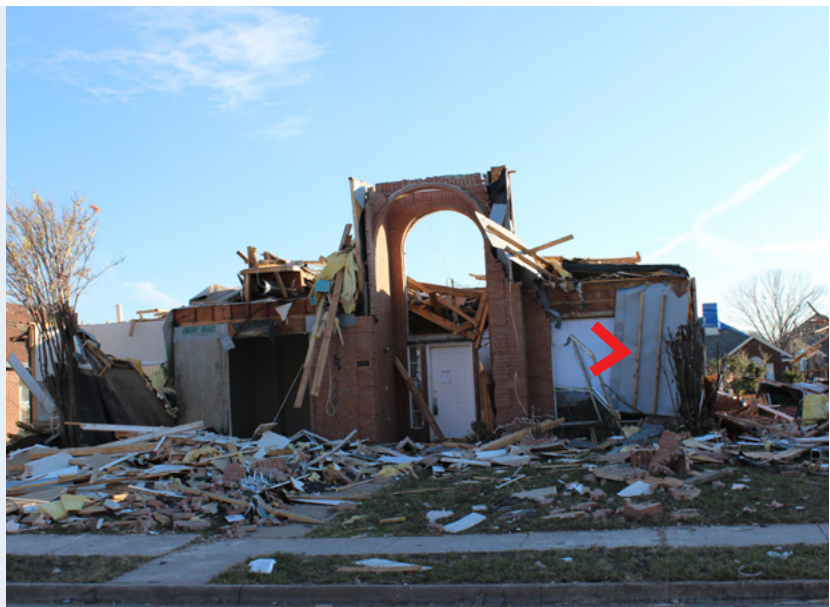
FIGURE 45:

A common observation of tornado damaged homes in the Garland/Rowlett tornado was poor integration of the top plates of exterior walls by the laminated-fiber wall sheathing. The top plate in this example is not lapped by the wall sheathing and results in partial loss of the top plate. Loss of the top plate framing would have likely been the weakest link in the uplift load path, had rafters been better connected to the top of the wall.

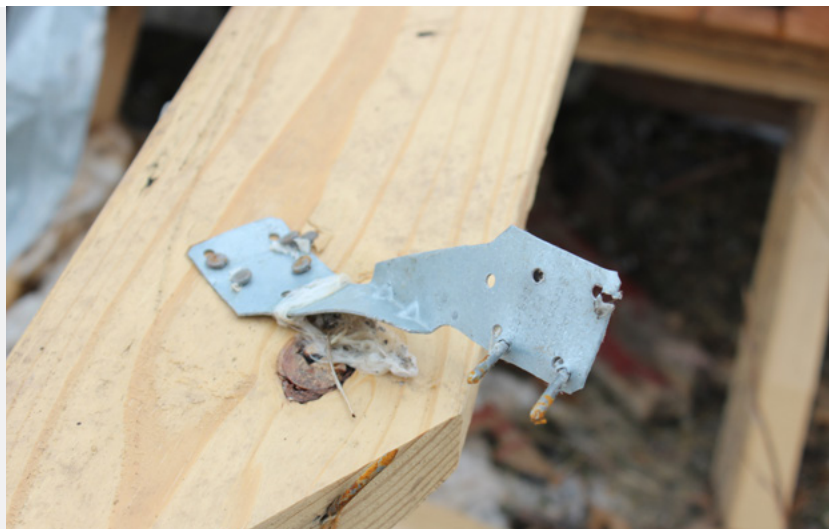
**FIGURE 48:**

The exterior walls of many homes were observed to be partially or completely lost from the connection to the foundations. In this case, powder-actuated pins were used to connect the bottom plate of the walls to the foundation. In most cases, the penetration of these pins into the concrete foundations was observed to be minimal. In every case where this condition was observed, pins were inadequate to function as a replacement for code-required foundation anchorage.

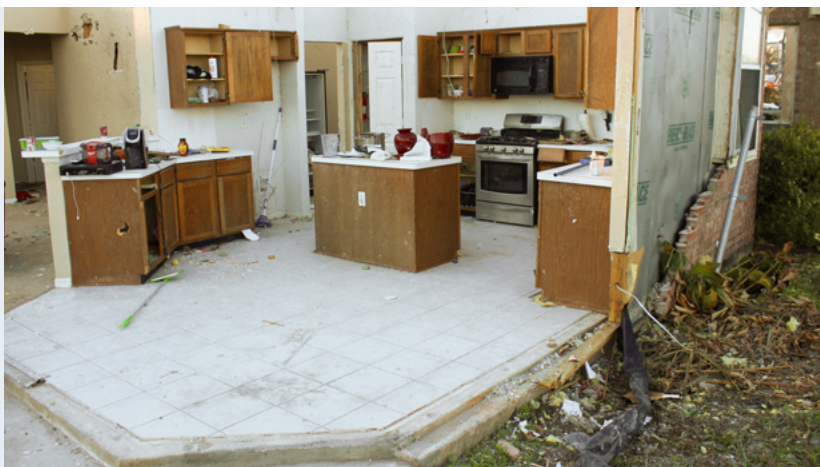
**FIGURE 49:**

In very few cases, damaged walls were observed to contain anchor bolts embedded in the concrete slabs for wall connections. Anchor-bolt connections are more predictable and robust than those created using powder-actuated pins. Anchor-bolt connections can be further enhanced by using larger plate washers atop the bottom plate for better resistance to bottom plate splitting.
