# Texas Tornado

**DAMAGE ASSESSMENT REPORT**

STRUCTURAL PERFORMANCE OF  
MODERN HOMES CONSTRUCTED  
IN THE DALLAS SUBURBS OF  
GARLAND AND ROWLETT, TEXAS

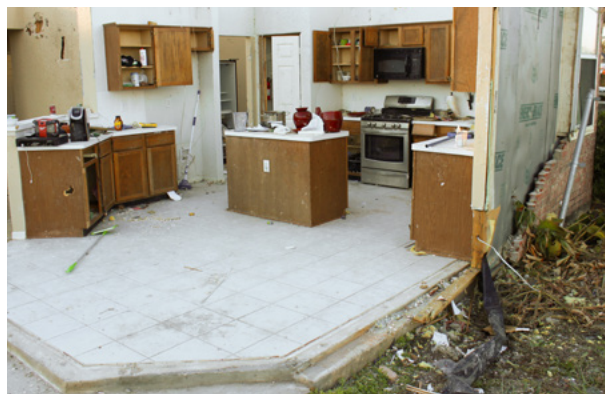
Another common observation across a wide range of wind severity was the loss of exterior walls due to poor attachment to the foundation. In many of these cases, powder-actuated pins of varying lengths were used to attach the bottom of support walls to the concrete-slab foundations. Although equivalent systems are allowed to be substituted, modern building codes generally specify deformed steel anchor bolts to be embedded into reinforced concrete foundations for attachment of wood framing.

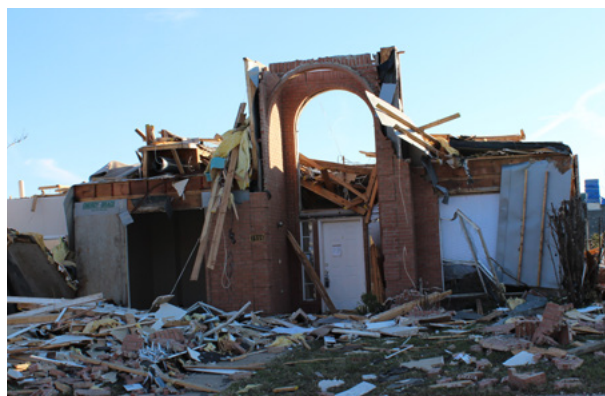
Most of the homes observed as a part of this survey were sheathed on exterior walls with a flexible laminated-fiber sheathing that measured approximately 1/8 inch in thickness. The walls were either fully or mostly clad with brick veneer on the exterior. Common problems in the strength of walls sheathed with laminated fiber included poor load-path continuity of framing within wall systems, especially at wall corners, and within wall systems stacked vertically between stories. These walls also performed poorly in resisting racking forces from lateral wind loads.

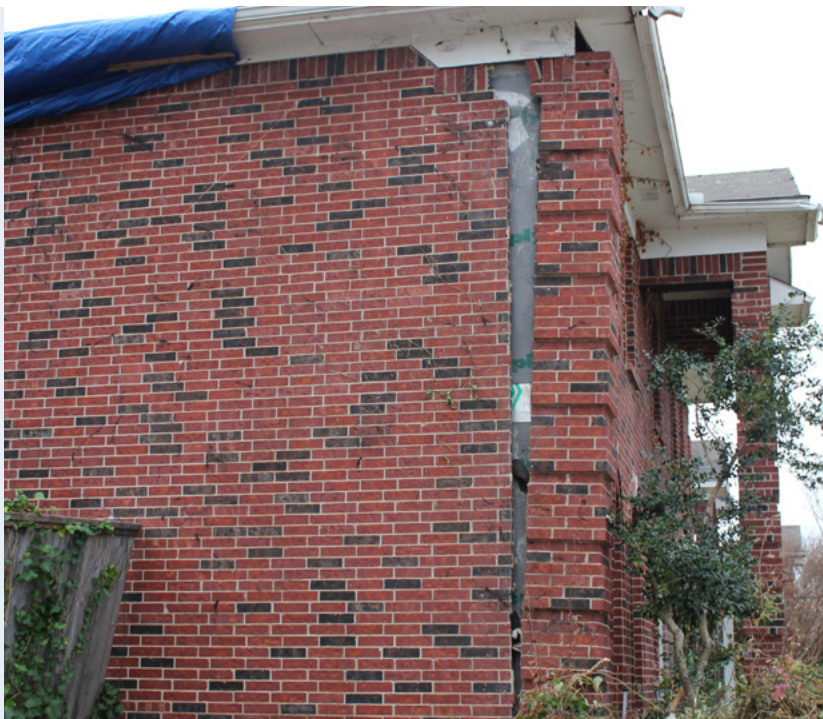
**FIGURE 5:**

A home on Barton Creek Drive, Rowlett, TX, constructed in 1992. In areas where lower wind speeds were experienced, homes fully clad with brick veneer commonly experienced cracking in the veneer adjacent to corners. This is likely due to excessive lateral displacement, or drift, for brick veneer walls sheathed with the relatively flexible laminated-fiber wall sheathing. A vertical crack that widens toward the top is visible in the brick veneer near the left-front corner of this home. Laminated-fiber wall sheathing is visible behind the brick veneer at this crack. Based on damage indicators such as nearby trees and high-resolution wind-speed contour maps by NWS, the tornado in this area is rated as EF0 rating or below. EF0 is around or below the design wind speed from ASCE 7.

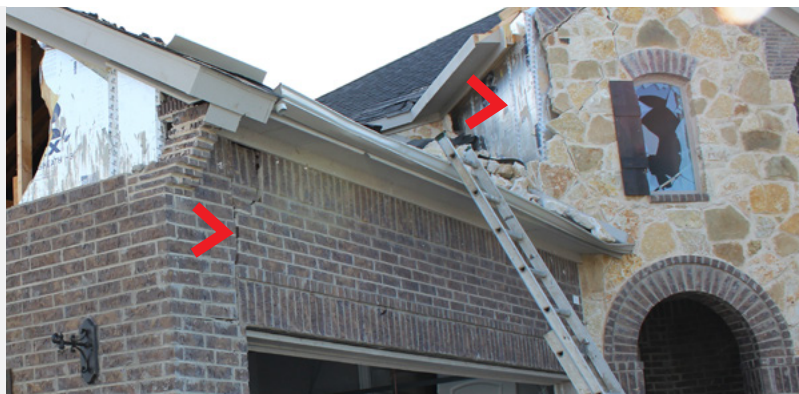
FIGURE 8:

Chianti Drive, Rowlett, TX. This is the adjacent corner of the home shown in the previous photo. Cracking in the brick at the corners of the garage door opening are present in addition to the collapsed brick. Loss of stone veneer was also observed where it stacks continuously from the foundation to an area above the roof, visible on the right of this photo.

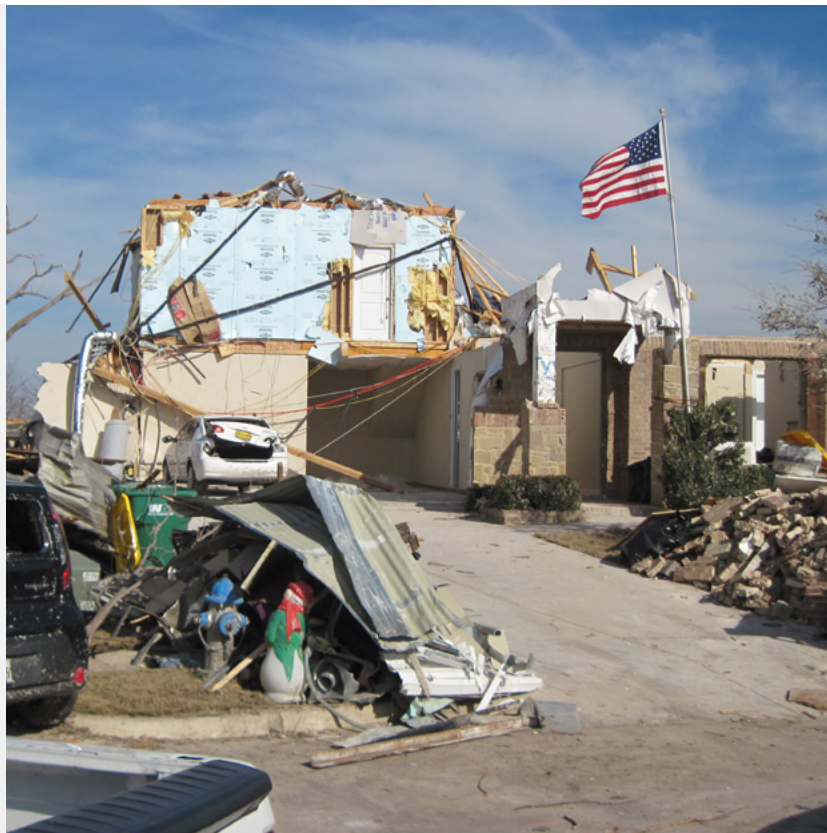
**FIGURE 18:**

Constructed in 2012, this 1-1/2 story home on Lindsey Drive in Rowlett, TX, was impacted by the tornado within the range of EF1 to EF2 rating, based on the degree of damage to vegetation and roof coverings of nearby intact homes. The large roof formerly covering the garage and upper-level living space was probably lost after the garage opening was breached and the interior was pressurized. Poor load-path continuity made damage to this home much worse than what would be expected in a well-constructed home. The survival of the second floor walls surrounding the living space can be largely attributed to the interior drywall, since foam sheathing on the exterior of these walls has no significant strength.

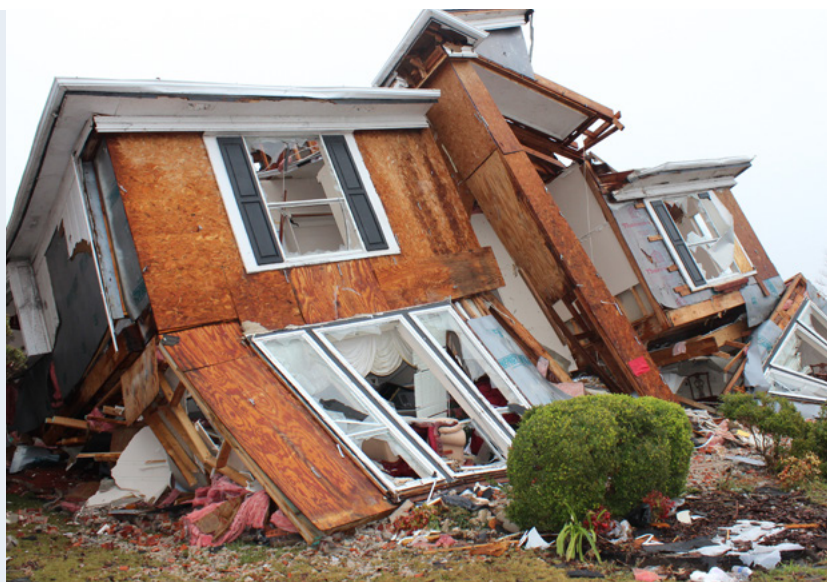
**FIGURE 29:**

This home located on Willowbrook Drive was intermittently sheathed on walls with WSP and infilled with laminated-fiber sheathing. Soft-story failure in this home resulted from inadequate capacity of wall systems to carry lateral wind forces. Collapses such as this obviously represent a serious life-safety issue. An abundance of openings on the first story walls of this home should signal the designer to pay special attention to the wall bracing specified in the building code for lateral resistance. In addition, a very limited number of brick veneer ties were observed on this building.

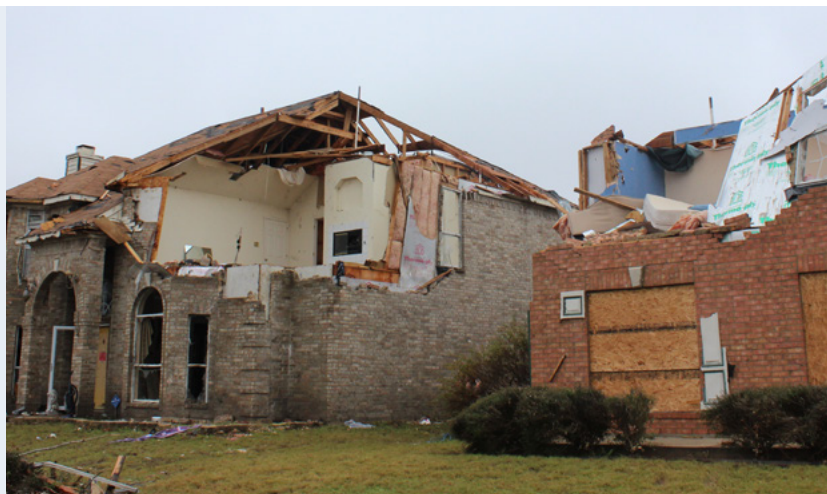
**FIGURE 32:**

These are the homes on Eagle Drive in Rowlett as shown on Google Street View prior to the tornado. A breach at the second story bay windows on the left building likely resulted in pressurization of the interior of the home and loss of the roof over this area.

A large porch overhang on the home on the right and a lack of uplift connectors made this roof vulnerable to uplift forces. Large positive pressures acting upward on the porch ceiling are roughly equal to the positive "stagnation" pressure exerted inward on the second-story walls. This upward pressure on the ceiling combines with negative pressure on the top roof surface, making this section of roof more likely to fail. Source: Google Street View.

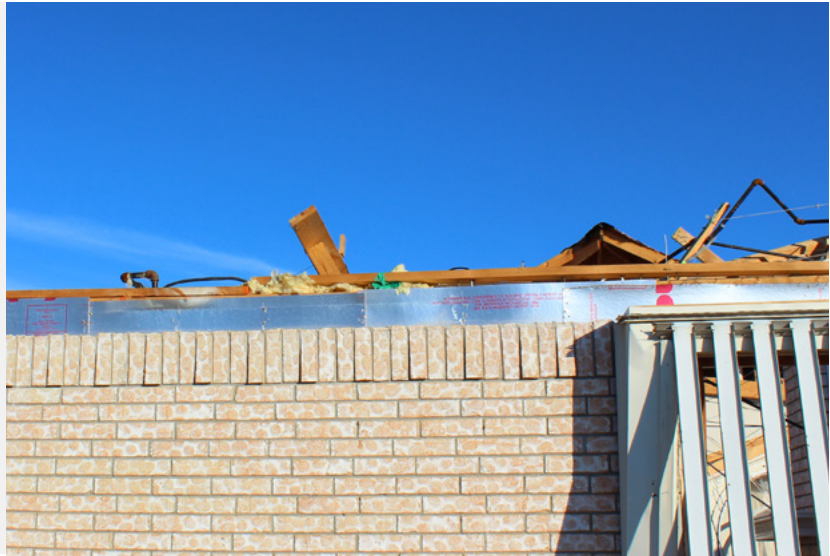
FIGURE 45:

A common observation of tornado damaged homes in the Garland/Rowlett tornado was poor integration of the top plates of exterior walls by the laminated-fiber wall sheathing. The top plate in this example is not lapped by the wall sheathing and results in partial loss of the top plate. Loss of the top plate framing would have likely been the weakest link in the uplift load path, had rafters been better connected to the top of the wall.

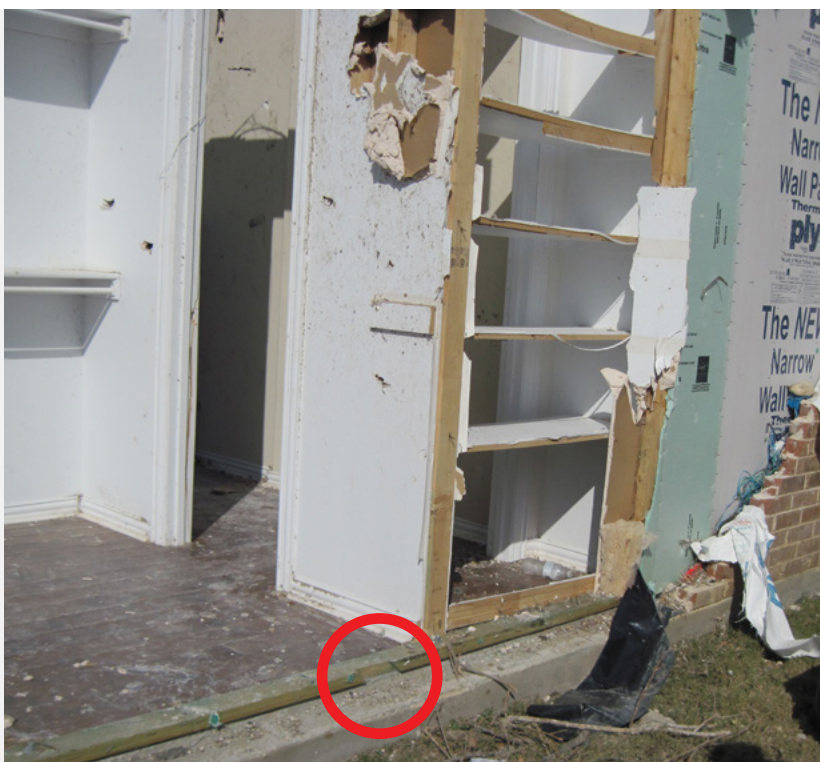
In very few cases, damaged walls were observed to contain anchor bolts embedded in the concrete slabs for wall connections. Anchor-bolt connections are more predictable and robust than those created using powder-actuated pins. Anchor-bolt connections can be further enhanced by using larger plate washers atop the bottom plate for better resistance to bottom plate splitting.

In this case, the wall sheathing was inadequate to provide continuity between the bottom plate and the wall studs. A notch in the outside edge of the bottom plate is visible in this photo where diagonal bracing was used to supplement the lateral resistance of the wall bracing. A combination of laminated fiber and XPS foam exterior wall sheathing is visible on the right side. Foam wall sheathing has no structural capacity and is not acceptable for use as wall bracing.

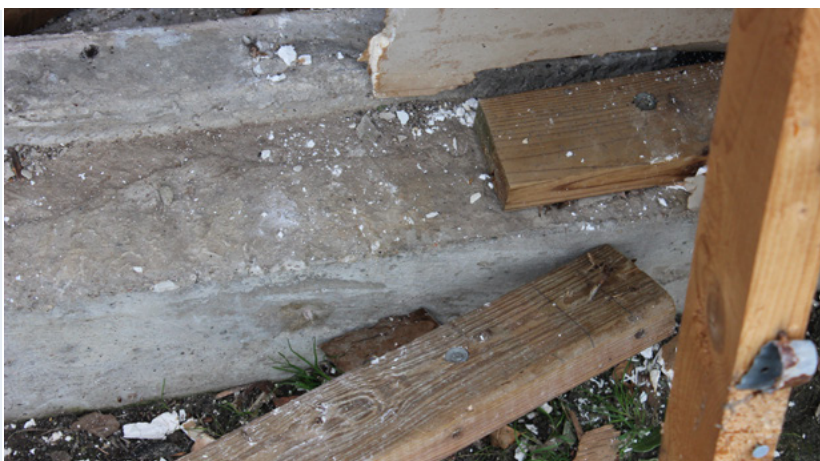
**FIGURE 50:**

In newer homes affected by the tornado, the primary means of attachment for the wall bottom plates to the concrete slab was powder-actuated pins. In many cases these fasteners protruded only 1/2 inch or less below the bottom of the wall plates. Small conical-shaped holes in the concrete were typically observed at these fastener locations. Some manufacturers of powder-actuated pins recommend embedment of 1-1/4 inches into concrete.
